Final Inspection Report

Name: [REDACTED]
Address: [REDACTED] Town, LongGang District, ShenZhen
Contact Name: [REDACTED]
Contact Email: [REDACTED]
Contact Number: +86 [REDACTED]
Inspection Date: June 28, 2008
Inspection Location: Factory Address (See Above)

Product Name: Dining Chair
Product / Item Number: 0[REDACTED]-2#
Quantity Ordered: 1200
PI Number: [REDACTED]#
Styles / Colors: (Beech Wood in Maple Color) (Moro-fibre Fabric in Chocolate color No.09#)

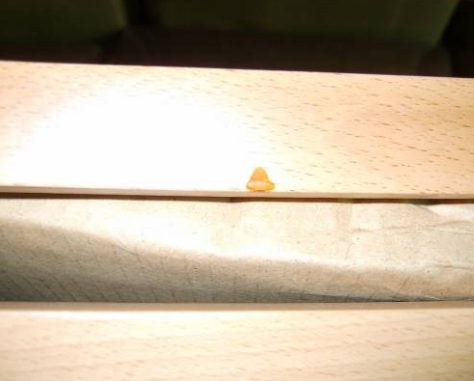
4 - MAJOR Stain (.25") (high visibility)

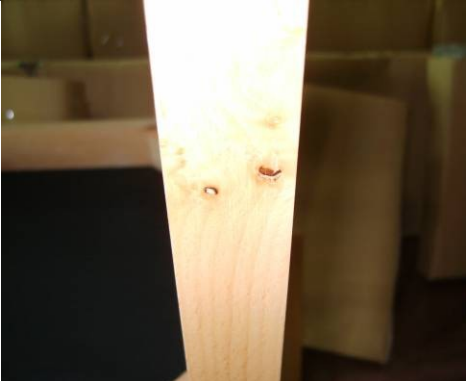
MINOR DEFECTS		
1 - MINOR Knots (.25") (Medium Visibilty)

Additional Remarks: The number off chairs with small knots and discoloration (flecks) was abnormally high. Factory should choose better raw wood for processing.

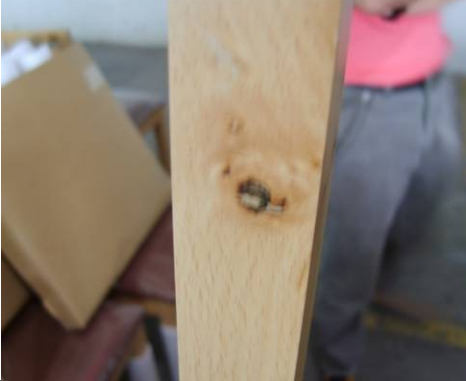
2 - MINOR Knot (.5") (Medium Visibilty)

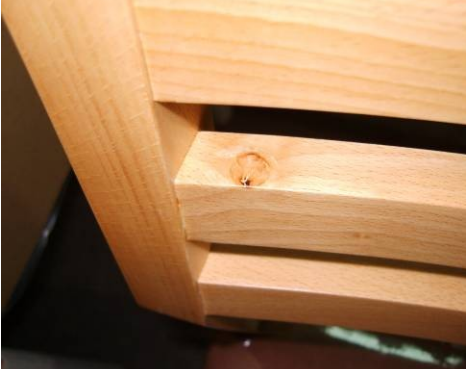
3 - MINOR Knot (1") (High Visibilty)

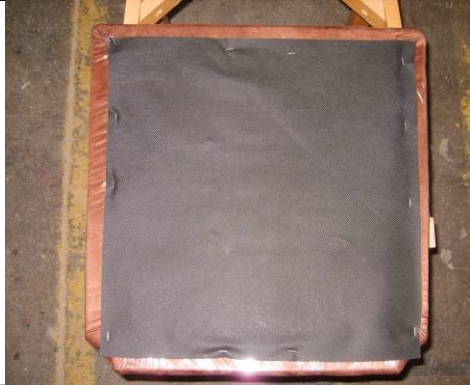
Front Blocks – Level and Flush	Rear Blocks – Unlevel and Flush

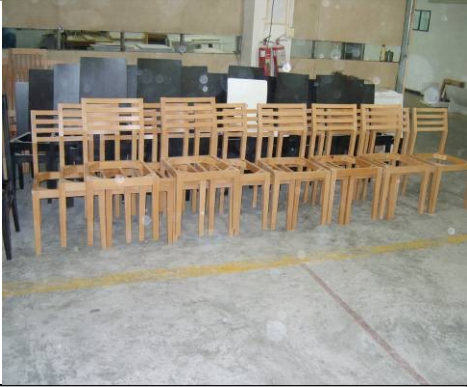
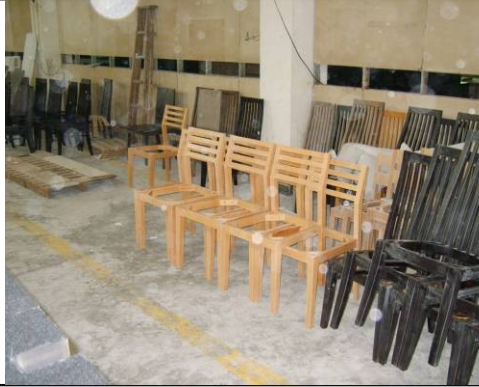
Quantity Ready to Ship / Inspect: 367 units – 33 units were being reworked due to bad finishing (see REWORK section below)

24 units in the sanding room

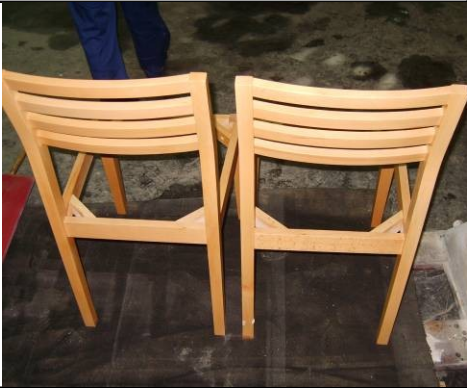
2 units in the spraying room

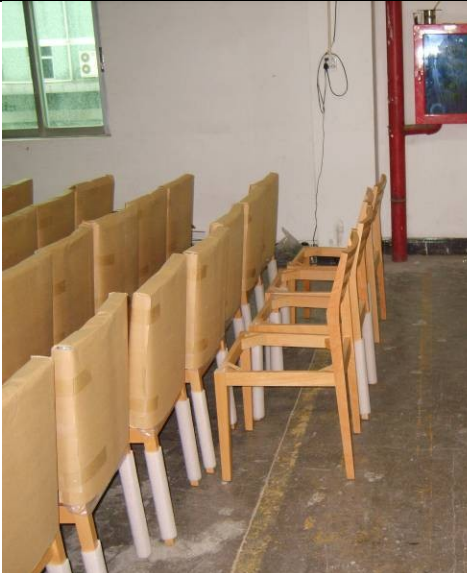
4 units in the finished goods area
